**Interstate 30: US Highway 70 - Sevier Street
Pavement Condition Report
January 2013**

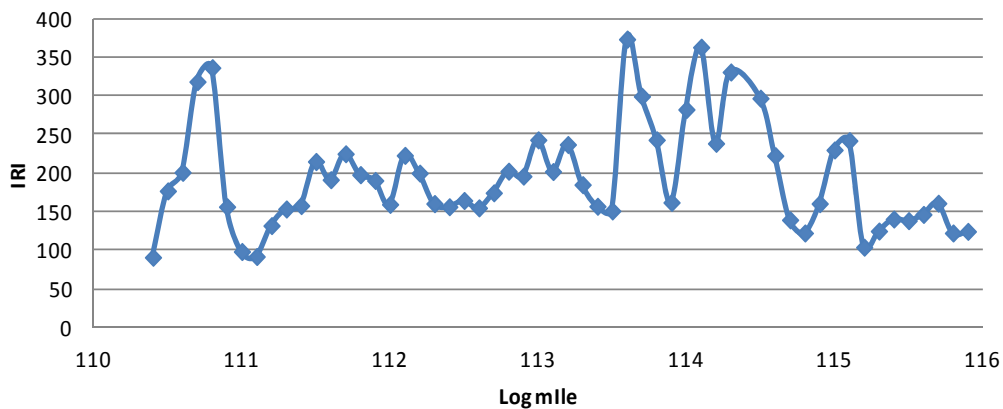
Figure 2. Eastbound IRI

Prior to rehabilitation, additional data collection was performed, including International Roughness Index (IRI), rutting, and pictures of the initial pavement condition. An Automatic Road Analyzer (ARAN) was used to collect IRI, rutting and pictures of the pavement. A lightweight profiler was also used to collect smoothness data on the pavement. The preconstruction IRI values ranged from 90 to 425 inches per mile (see **Figure 2** and **Figure 3**).

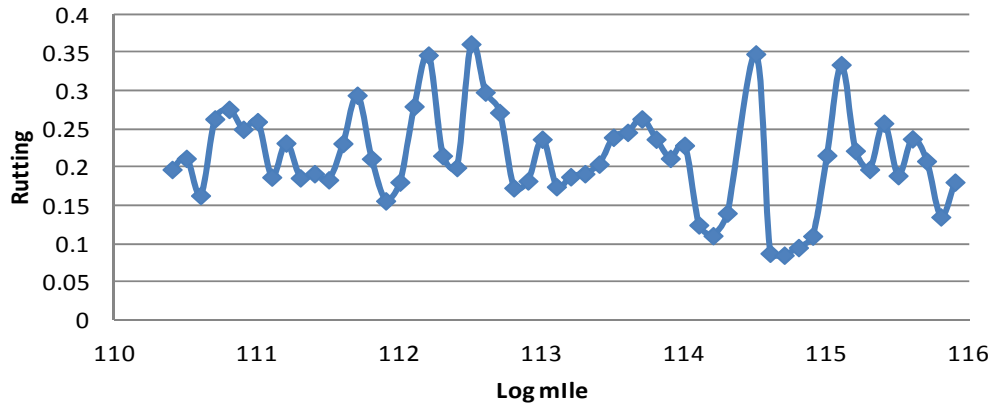
Figure 4. Eastbound Rutting

Rutting on the interstate ranged from 0.085 to 0.42 on an inch for the east and westbound lanes (**Figure 4** and **Figure 5**).

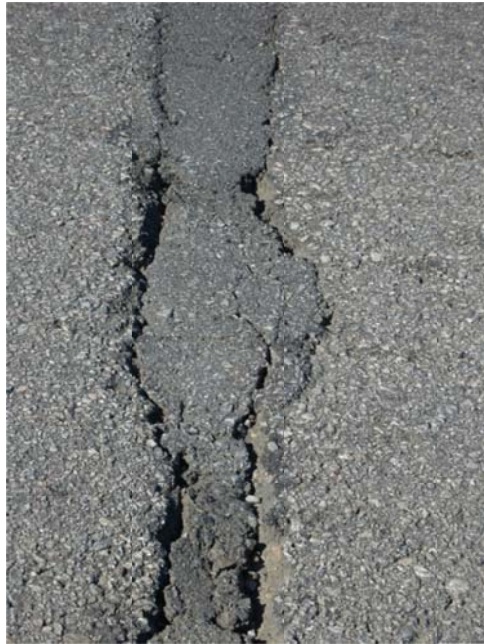
Picture 1. Joint Condition

The severe moisture damage at the joints has caused the joints to become wider than average reflection-crack joints. The joints ranged in width from one-half to three inches and many of the joints have been patched. Two examples of the pre-overlay joint condition can be seen in **Picture 1** and **Picture 2**.

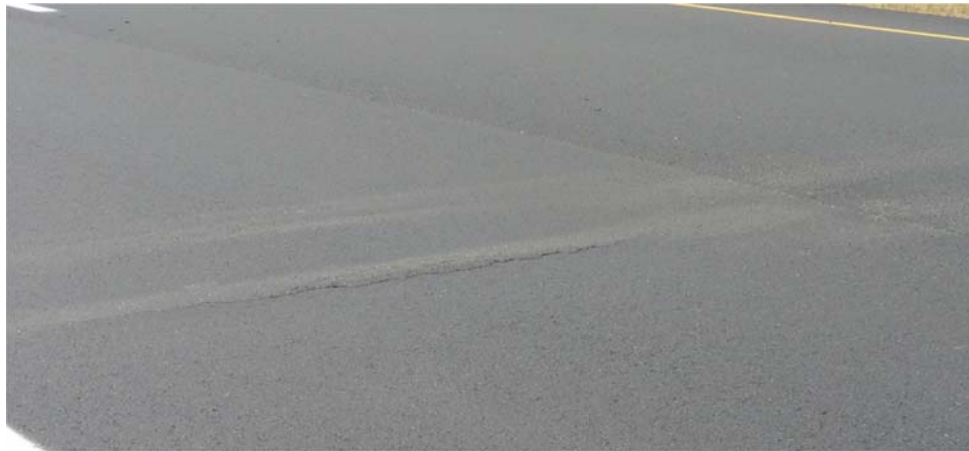
Paving of the road began the night of July 11, 2012 and all paving was done at night due to the traffic on the Interstate. Paving was cancelled several nights due to rain. Overall construction of the overlay went well. There was an approximately half-mile section of joints that puffed up after paving. It was presumed that the puffy joints were caused by moisture in the joints from the rain.

Picture 3. Bump at Joint
